# MICROSTRUCTURAL AND MECHANICAL PROPERTIES OF FAILED COUPLING WITH AN AIRLOCK IN A FLOUR MILL

*In the present work, we report the microstructural and mechanical properties of failed coupling with an airlock in a flour mill. The coupling which was made of aluminium alloy is used to transmit torque from the electric motor to an airlock used on a flour mill production line. The fracture that occurred at the root of the teeth of the coupling was investigated using various tests and analysis. The tests includes: macro examination, micro-structural examination, composition analysis, hardness and tensile test were employed for this investigation. From the tests carried out, it was observed from the macro examination that the coupling undergoes a brittle failure. However, composition analysis revealed a relatively high weight composition of aluminium (87.5 wt. %) suggesting that the coupling was made of aluminium based alloy. The significant presence of Cu and Zn at 2.77 wt. % and 1.03 wt. % respectively indicates that the alloying elements were mainly of copper and zinc. The tensile test result revealed that the material has an ultimate tensile strength of 178 N/mm<sup>2</sup> which is

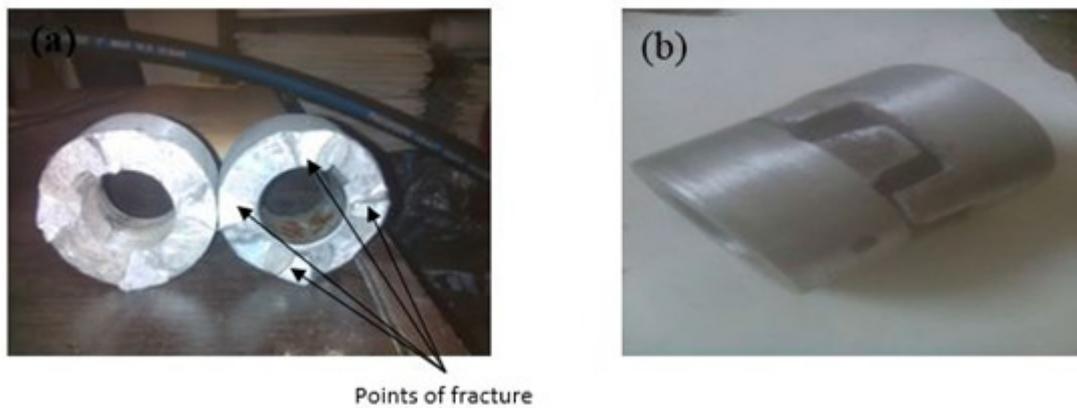
**Figure 2(a-b).** Failed coupling and complete coupling.

Physical examination using the naked eye revealed flat surfaces at points of fracture. This is a characteristic of brittle failure and indicating that the failed coupling may have experienced a brittle failure. The crack movement is perpendicular to the applied stress which is cyclic. This also supports the earlier prediction that the coupling may have experienced a brittle failure.

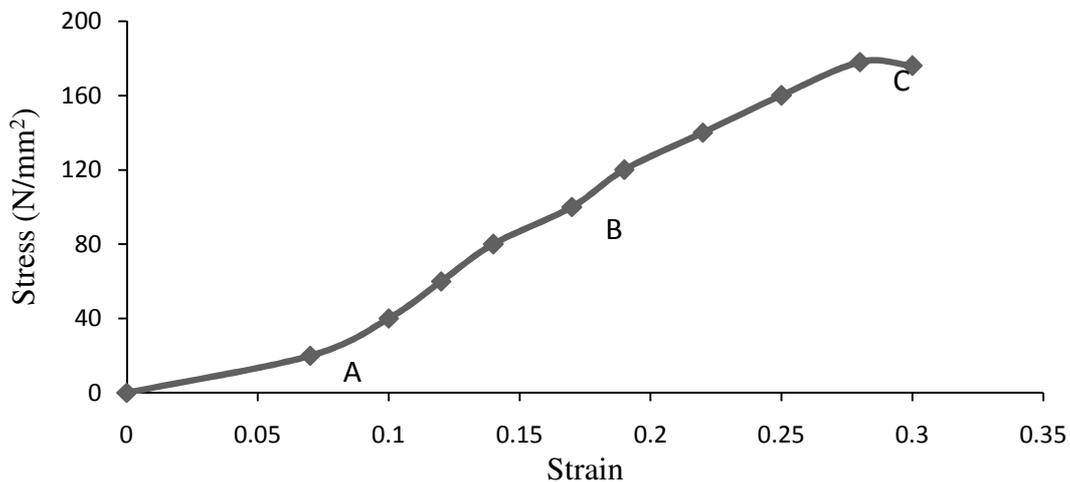
The stress-strain graph of the fractured coupling in Figure 4 indicate the curve starting from the origin as a straight line, this is because the force increases in direct proportion to the extension of the specimen up to point A. At this point, the extension remains proportional to the applied force, and the sample is said to obey the Hooke’s law. This region of the stress-strain curve is called the elastic extension region. The fractured coupling has an ultimate tensile strength of 178 N/mm<sup>2</sup> which is comparatively lower than that of most aluminium alloys. This might be as a result of the high Si composition of 7.24 wt. % observed from the chemical compositional analysis. The low ultimate tensile strength reflects poor tensile properties and might have been a reason for the fracture of the coupling. The origin to the point labeled A is the proportional limit region, where the applied force seems to be proportional to the extension. Above this limit is the elastic limit region labeled B, which is the point in which the sample would return to its original length if the applied force is removed. The plastic deformation region labeled C is the region where the ultimate tensile strength is recorded and the breaking strength is also recorded as the point where the test sampled fractures.

**Figure 4.** Stress-strain graph of the fractured coupling

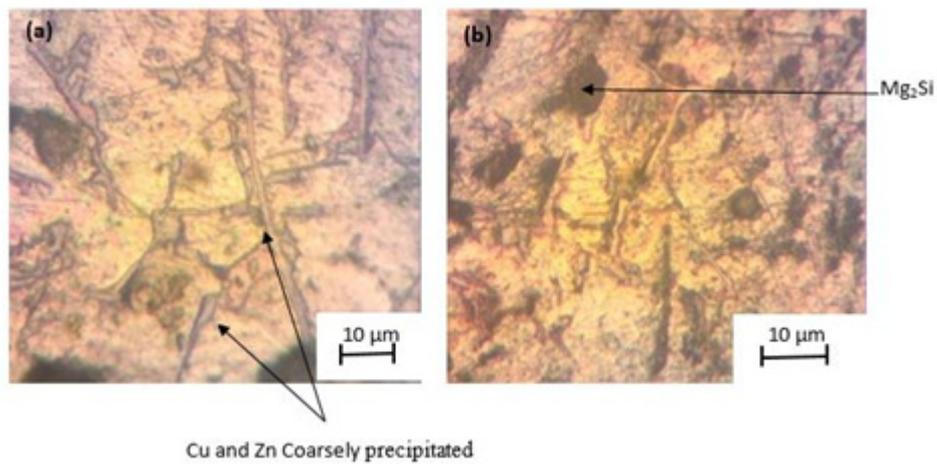
The microstructure examination of the fractured coupling was carried out at three different parts labeled section A, B and C in Figures 5a-c. A highly coarse precipitation of Zn and Cu compounds with little precipitation of Mg<sub>2</sub>Si at the Al matrix boundaries was noticeable in Figure 5a. Mg<sub>2</sub>Si is suggested to be the black clusters within the micrographs been observed by [8].

**Figure 5a-b.**Section A and B of the micrograph.

Section A of the coupling shows high concentration of the alloying elements serving as reinforcement, making this section more ductile and would exhibit little strength because the elements are not properly distributed within the matrix of the aluminium alloy. Section B shows clusters of Mg<sub>2</sub>Si with very little Zn and Cu precipitated within the aluminium alloy matrix. This section would be slightly brittle compared to section A, due to the lack of

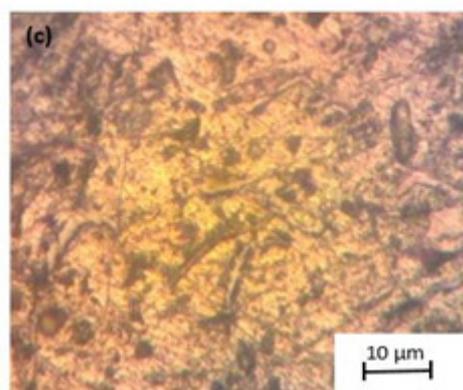
**Figure 5c.**Section C of the micrograph

adequate presence of Zn and Cu reinforcement in this section. Section C shows slight proportional mixture of Mg<sub>2</sub>Si, Zn, Cu and Al compounds precipitated within the matrix boundary of the captured region. This section according to the micrographs is the best of the three sections, having proper mixture of the base element and the other alloying elements. Section C exhibits little grain sizes and well-structured grain structures well distributed along the aluminum matrix boundary, causing good intermetallic and interfacial bond within the coupling. Therefore sections A and B can fracture easily compared to section C when force load is applied on the coupling which might have added to the course of coupling failure.
