¹. J. K. ODUSOTE, ². S.I. TALABI, ³. G. AGODINRIN

EFFECT OF HEAT TREATMENT ON HARDNESS AND WEAR RESISTANCE OF A FAILED AUTOMOBILE BRAKE DISC

¹⁻². Materials and Metallurgical Engineering, University of Ilorin, Ilorin, NIGERIA

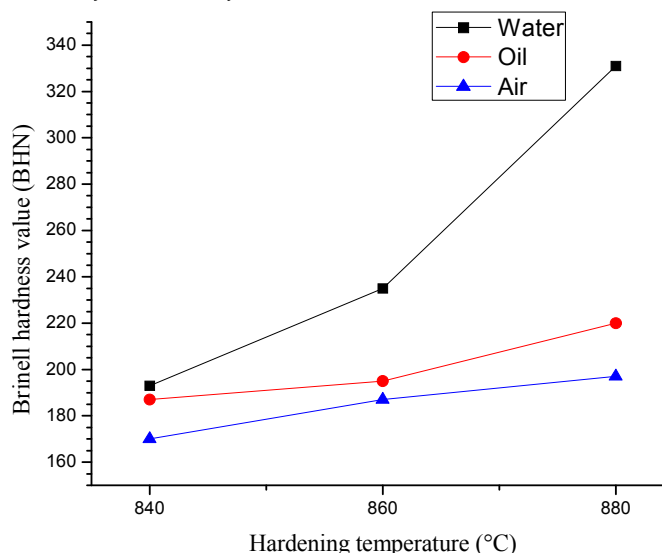
Figure 1: The hardness values of the samples quenched in different media (water, oil and air).

The hardness of the quenched and tempered specimens (Figures 1 and 2) were higher compared with the as-received specimen, with hardness value of 159 HBN. The hardness values increased with increased heating temperature with highest hardness of 331 HBR at 880°C obtained from the water-quenched specimen. This was followed by oil-quenched (220 HBR) and then air cooled (197 HBR) specimens heat treated at 880°C. The hardness value of the water-quenched sample also corresponds to the microstructural changes of austenite in the as-received to martensite. The hardness values of the tempered samples decreased compared with the un-tempered samples, indicating possible increase in ductility and

toughness. The presence of silicon in the cast iron reduces the solubility of carbon in austenite. Increase in austenitizing temperature increased the amount of carbon in solution [9], and subsequently give rise to higher hardness value as exhibited in water-quenched specimens at 880°C.

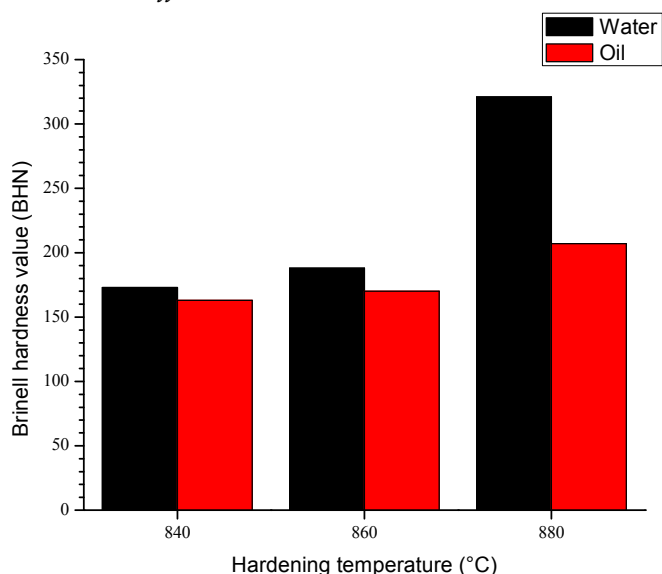
Figure 2: The hardness values (HBN) of the tempered specimens after quenching in water and oil.

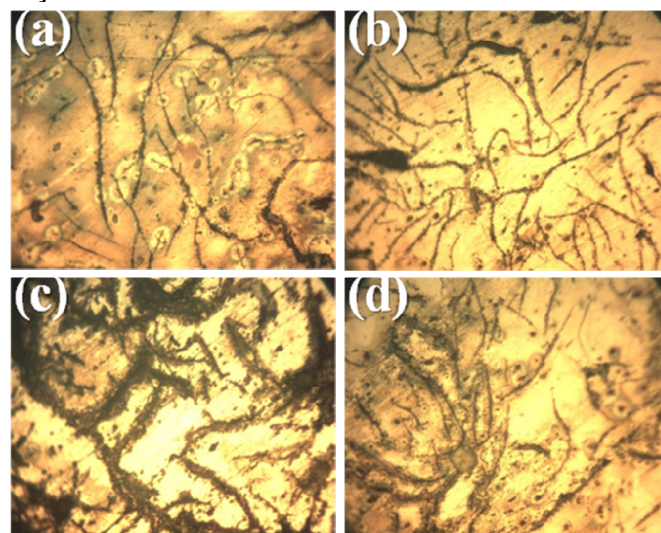
Figure 3: Optical micrographs showing microstructure before and after heat treatment at 880°C and quenching in: (a) As-received; (b) Water-quenched; (c) Oil quenched; (d) Air-quenched

Figure 3a is the optical micrograph of the as-received failed brake disc, which shows the presence of austenite, ferrite, cementite and flakes of graphite. The microstructure of the water quenched specimen (Figure 3b) revealed the presence of finely-dispersed ferrite with dendritic tempered martensite phase in a matrix of eutectic carbides, which gave rise to the high hardness value of

water-quenched specimens. However, similar microstructure was observed in oil quenched (Figure 3c) specimens with the ferrite not finely dispersed compared to the water-quenched specimen, but were mainly found along the grain boundaries. The amount of tempered martensite phase in a matrix of eutectic carbides was less in both the oil quenched and air cooled specimens (Figure 3d) when compared with the water quenched specimens. During tempering, there was growth of small carbide embedded in a ferritic matrix along with the transformation of retained austenite into martensite. The microstructure of tempered martensite consisted of extremely small and uniformly dispersed cementite particles embedded within a continuous matrix which may be nearly as hard and strong as martensite, but with substantially enhanced ductility and toughness [1, 10].

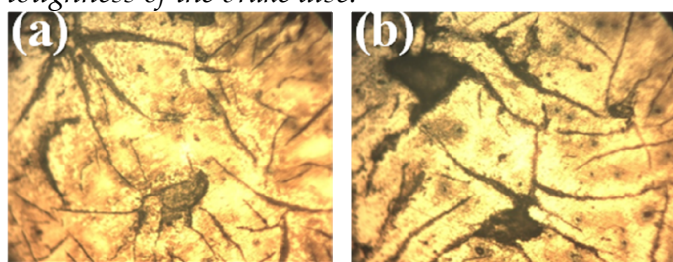
Figure 4: Optical micrographs showing microstructure after hardening at 880°C and tempered in: (a) Water-tempered; (b) Oil quenched

Figures 4a and 4b are micrographs of water and oil quenched and tempered specimens, which show part of austenite matrix formed transformed into martensite and tempered martensite with the presence of cementite which influenced the hardness of heat-treated specimens. In the course of the heat treatment, the austenitizing temperature, cooling rate and quenching media usually contribute to the precipitation of small carbide and formation of more uniform refined martensite of the heat-treated alloys. In addition, the presence of higher silicon content in cast -iron

gave rise to greater degree of decomposition of the cementite and coarse flakes of graphite produced [1, 5]. The effect of rapid cooling of water-quenched (tempered) specimens ensured the formation of tempered martensite, indicating significant improvement in toughness and ductility without sacrificing the high hardness value. Thus, from the results, it is proposed that heat treatment should be carried out at 880°C with appropriate quenching and tempering, to improve the wear resistance and toughness of the brake disc.
