# GROUND WATER USE NEAR AN OPEN DUMPSITE IN A PERI-URBAN COMMUNITY

Department of Water Resources and Environmental Engineering,  
Faculty of Engineering and Technology, University of Ilorin, Ilorin, Nigeria

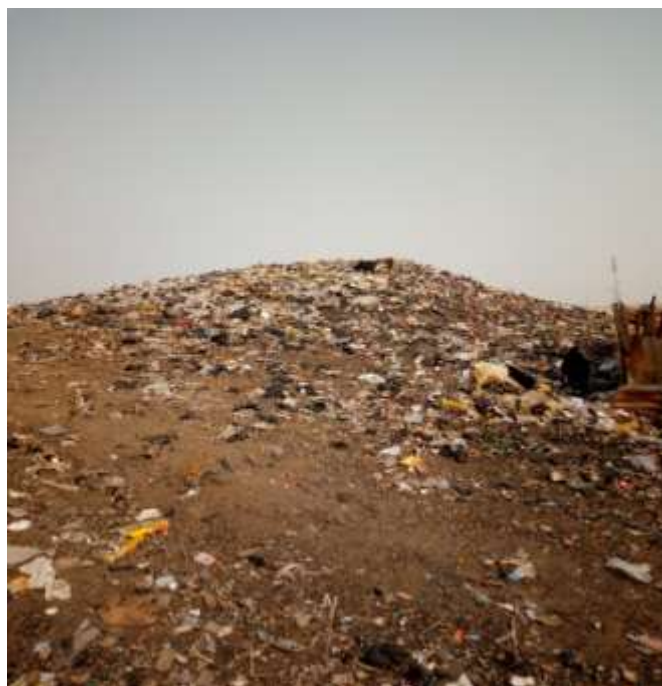
**FIGURE 2**  
The dumpsite under study

Reconnaissance survey was carried out in order to identify the location of groundwater structures around the open dumpsite. The open dumpsite is the only source of waste disposal in the community and the composition of waste materials in the dump site comprises of mostly paper, plastics, scraps, nylon, agricultural waste, human excreta and so on (Figure 2). Four hand dug wells were found close to the

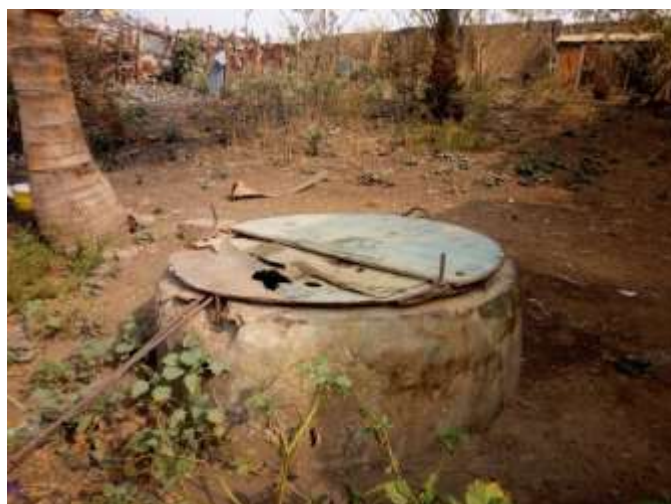
**FIGURE 3**  
GW1

dump site used for drinking and domestic purposes and they were tagged GW1, GW2, GW3, and GW4 (Figures 3 – 6). The internal and external diameter of the wells, the height of the ring above the ground surface, the depth of well, and the distance of the well to the dumpsites were measured during the survey before the water samples were collected as indicated in Table 1.

**TABLE 1**  
The sample Location and well characteristics

| | GW 1 | GW 2 | GW 3 | GW 4 |
|---|---|---|---|---|
| Internal diameter (m) | 1.00 | 0.90 | 1.23 | 1.40 |
| External diameter (m) | 1.40 | 1.25 | 1.55 | 1.80 |
| Depth of water (m) | 3.60 | 1.20 | 1.27 | 1.00 |
| Distance of well to the dumpsite (m) | 13.60 | 14.50 | 36.00 | 51.00 |
